ATSB TRANSPORT SAFETY REPORT

Aviation Occurrence Investigation – AO-2009-012

Preliminary

Tail Strike
Melbourne Airport, Vic.
20 March 2009
A6-ERG
Airbus A340-500

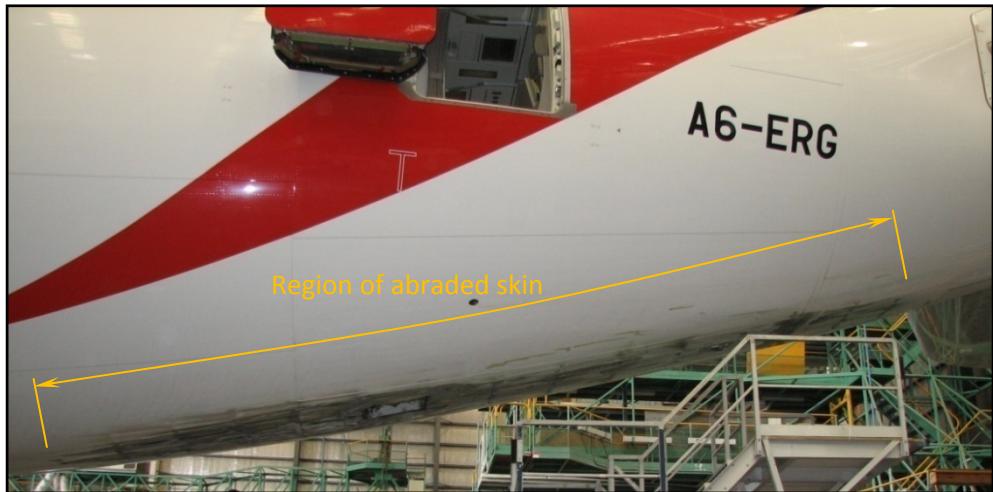
An initial inspection of the aircraft revealed that the rear of the fuselage was seriously damaged⁷. The lower skin panels were abraded by contact with the runway surface (Figure 1), and in some areas the skin had worn through the full thickness (Figure 2). A service panel had been dislodged (Figure 2) and was found by airport personnel at the end of the runway, along with numerous pieces of metal consistent with the abraded skin panels. Numerous fuselage frames and stringers in the region were deformed and several contained cracks (Figure 3). The rear pressure bulkhead⁸ contained cracks in the composite structure and deformation of the diaphragm support ring (Figure 4). There were also scrapes on the right side of the fuselage consistent with contact with external objects. One contact mark had an orange colouration and was located forward of the skin abrasion, immediately below the right, rear cargo door (Figure 5). The other contact mark was located adjacent to the skin abrasion and consisted of several, fine, divergent marks running rearwards and slightly upwards (Figure 6). There was also a contact mark on the left main landing gear, inboard rear tyre (Figure 7).

Figure 1: Skin abrasion

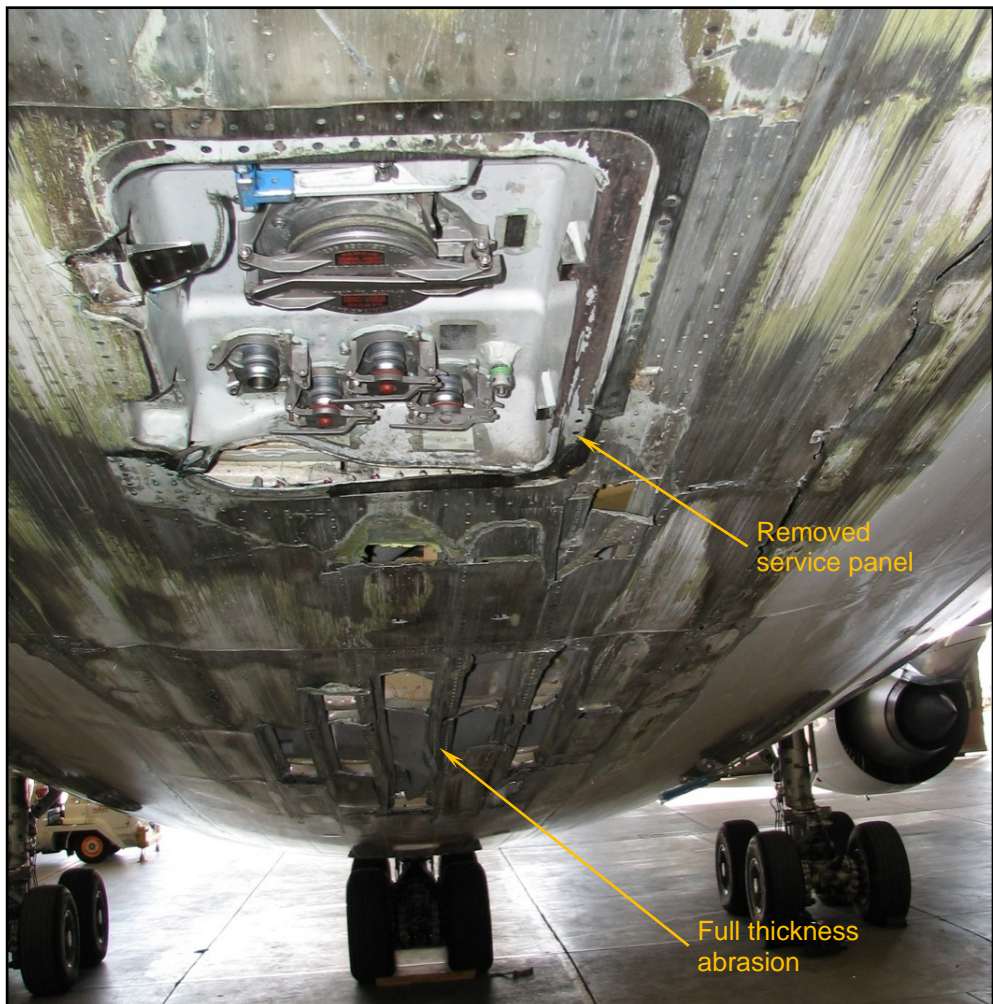
Figure 2: Skin abrasion detail

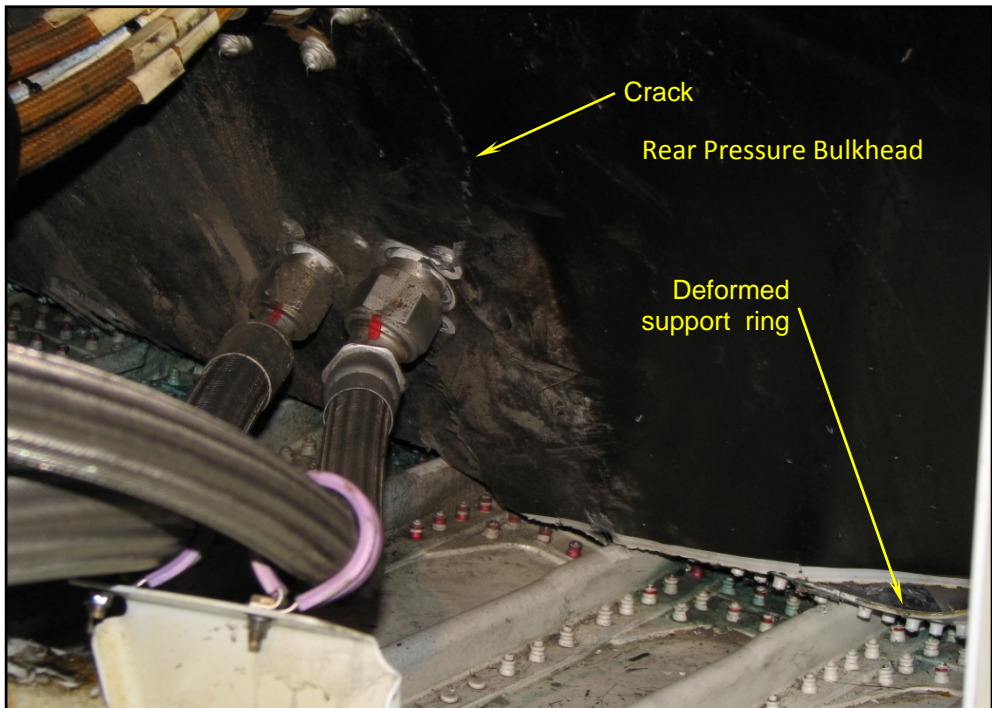
Figure 4: Example of rear pressure bulkhead damage

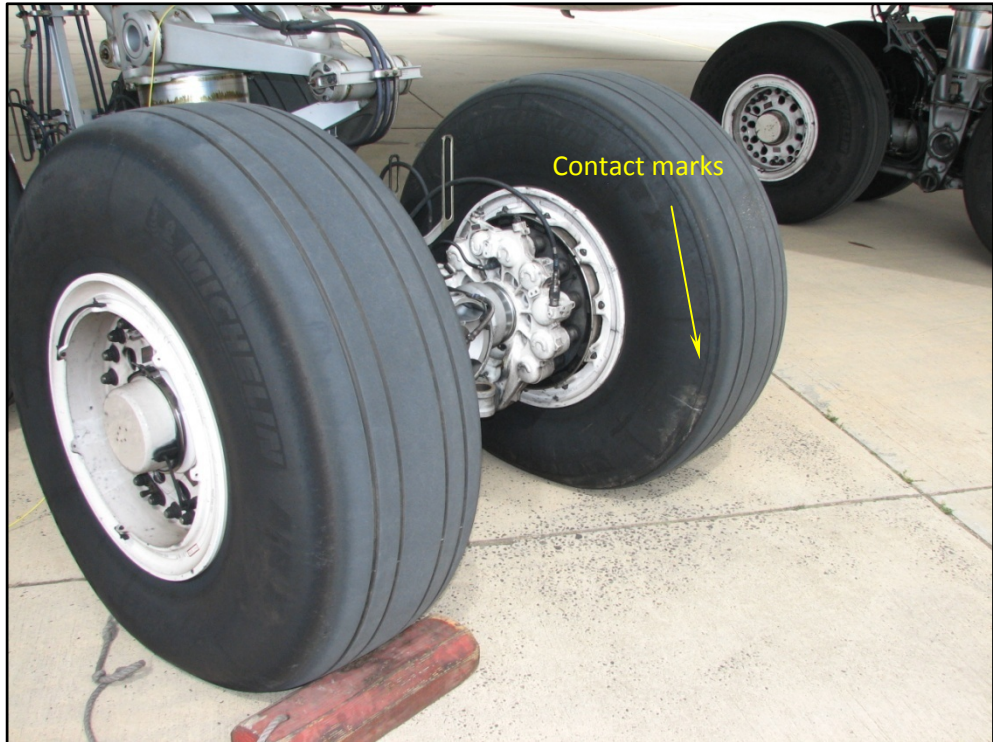
Figure 7: Contact mark on left main landing gear, inboard rear tyre

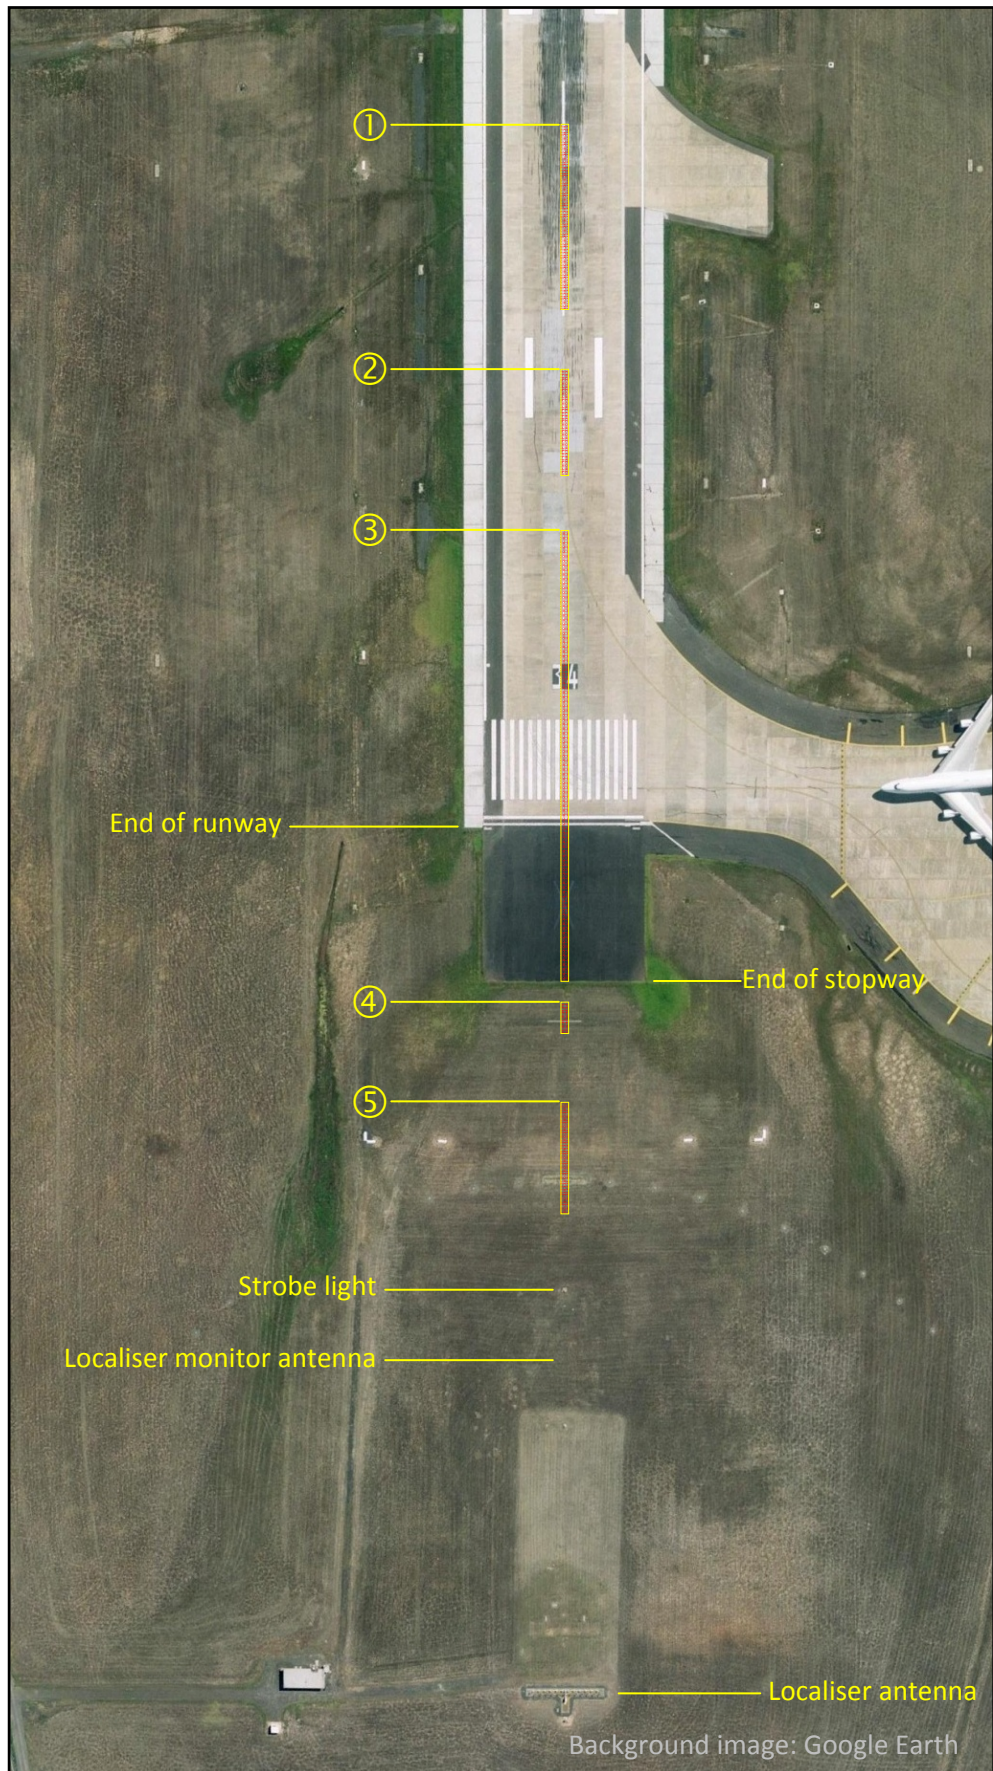
An inspection of the runway and overrun areas identified multiple contact marks (Figure 8). The tail of the aircraft made contact with the runway at three locations, each starting at the positions indicated by ① ② and ③ in Figure 8. After leaving the stopway, two contact marks were identified in the grassed area, indicated by ④ and ⑤ in Figure 8. Figure 9 shows typical ground contact marks. The aircraft also made contact with ground infrastructure; a runway 34 high-intensity approach lighting centreline strobe light (Figure 10), and the runway 16 localiser monitor antenna (Figure 11). The runway 16 localiser antenna (Figure 12) was contacted by the left main landing gear inboard-rear tyre. The damage to the localiser antenna disabled the localiser function.

Figure 8: Ground contact marks

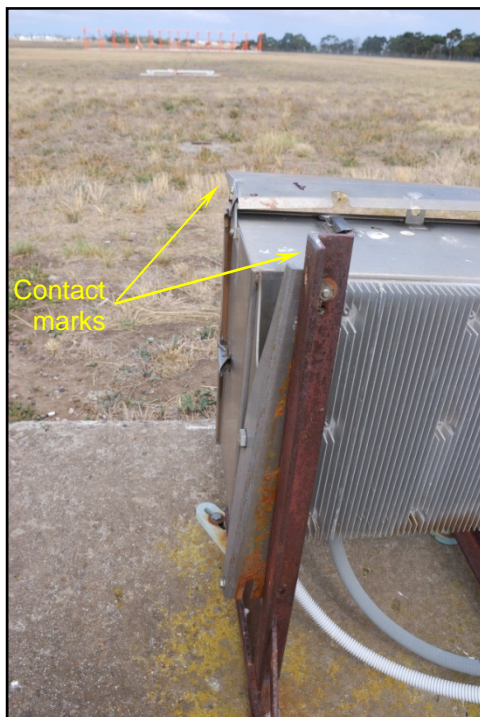
Figure 10: Strobe light

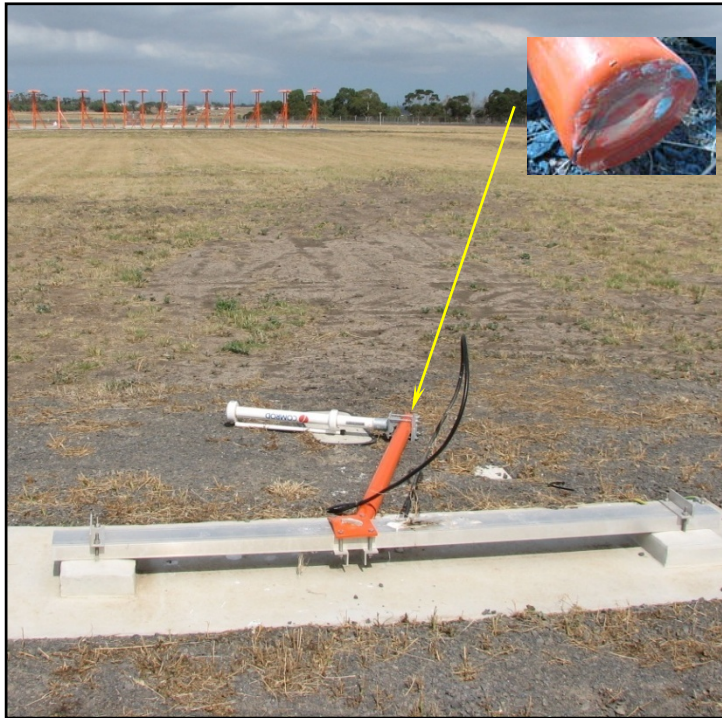
Figure 11: Localiser monitor antenna

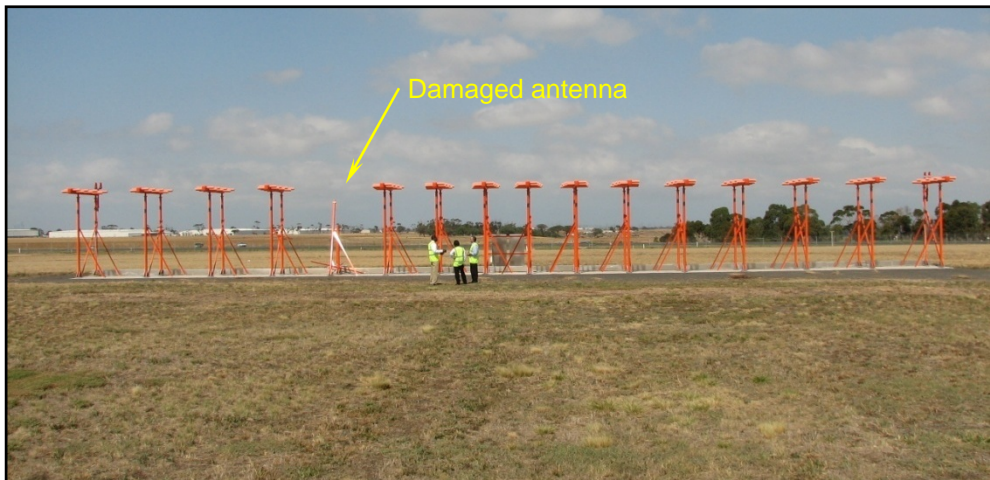
Figure 12: Localiser antenna array

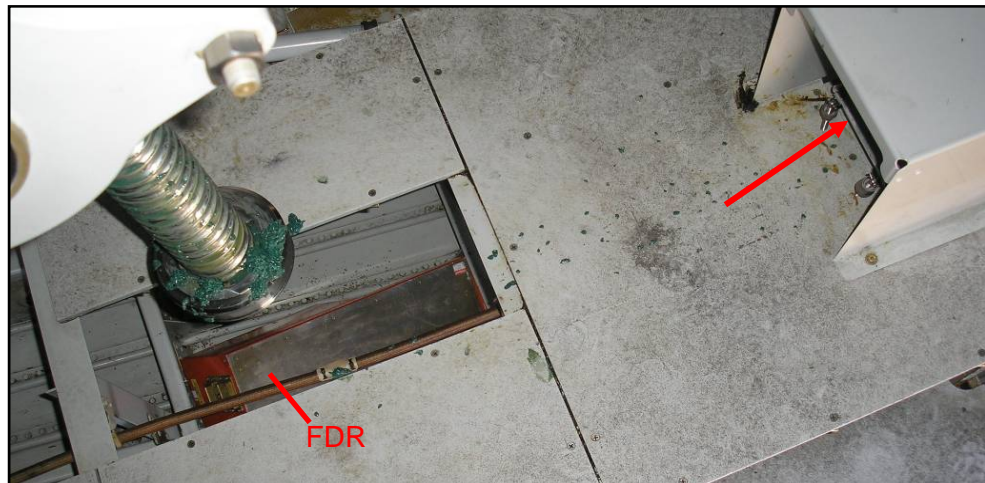
The examination and retrieval of the flight recorders was undertaken under Australian Transport Safety Bureau (ATSB) supervision on 21 March 2009. The FDR had separated from its mounting rack and was located in a small compartment directly to the rear of the mounting rack and adjacent to the tail lower skin.

Figure 13: Location of FDR as found with FDR mounting rack in view (arrowed)

The FDR mounting rack displayed evidence of deformation with part of one securing nut found to have also separated from the rack.

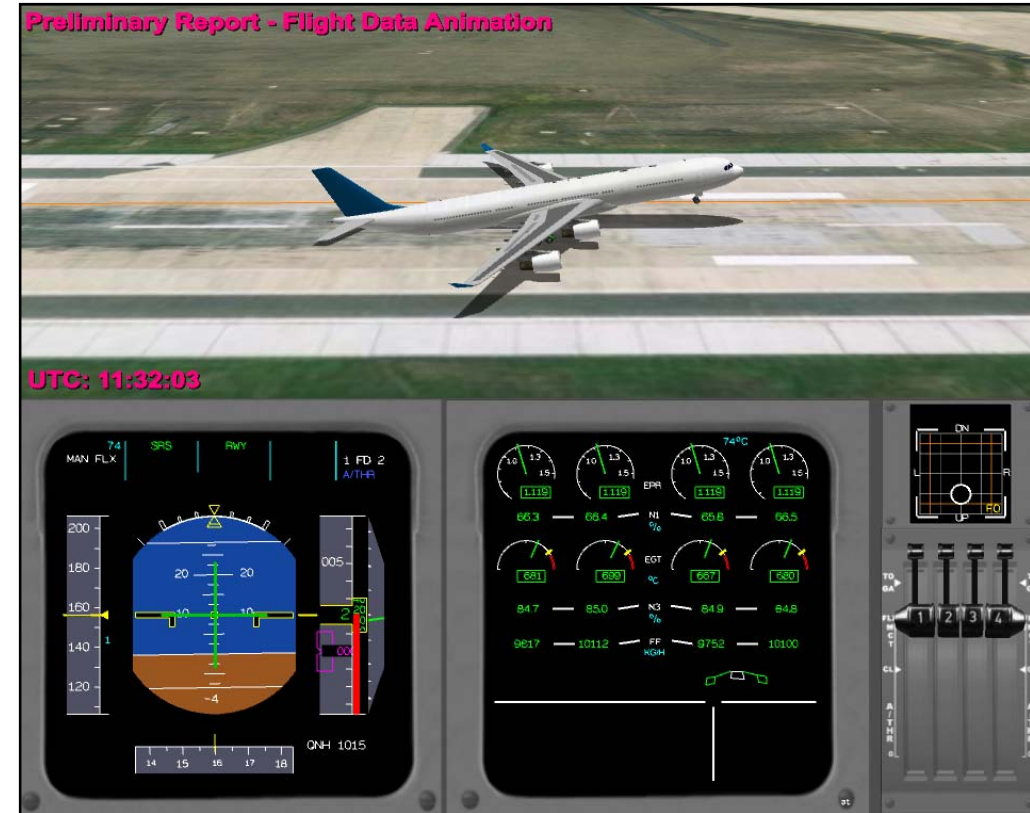
Figure B2: Initial tail contact with runway

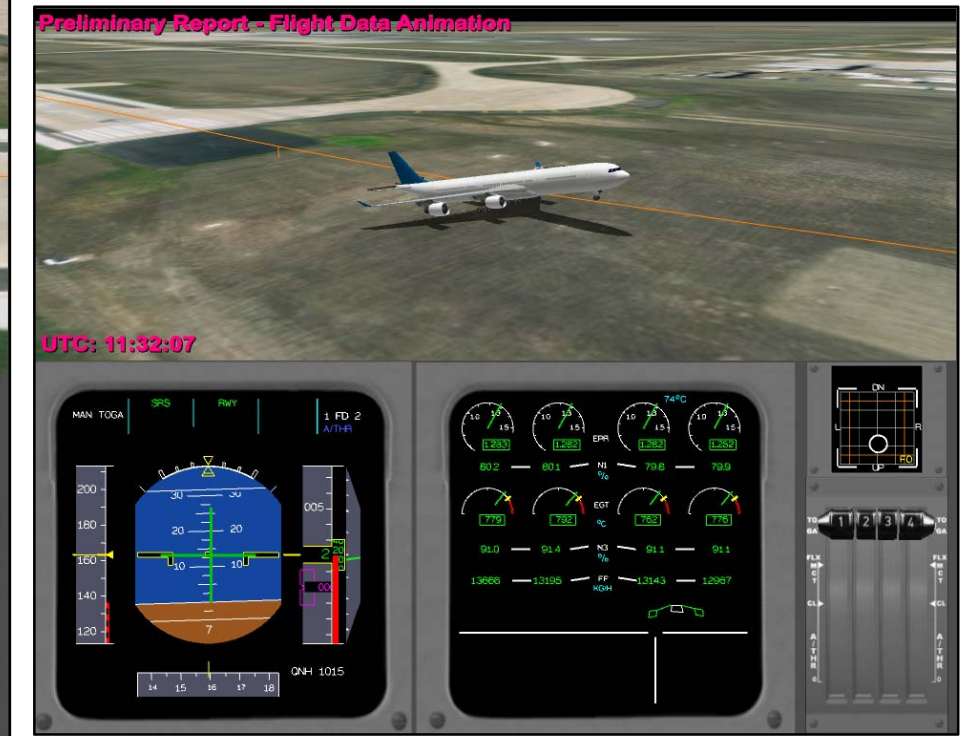
Figure B3: Final tail ground contact witness mark
